Report of the

# PRESIDENTIAL COMMISSION

*on the Space Shuttle  
Challenger Accident*

June 6, 1986

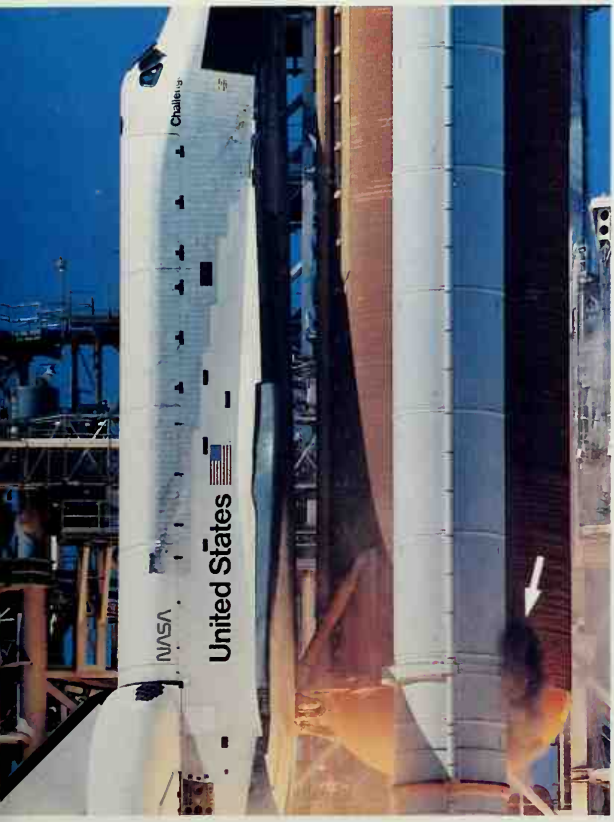
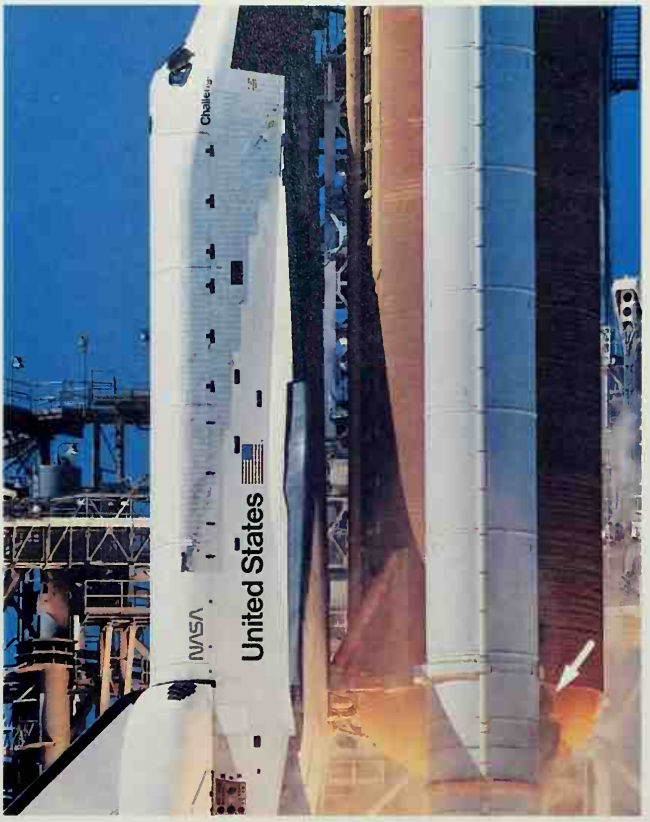
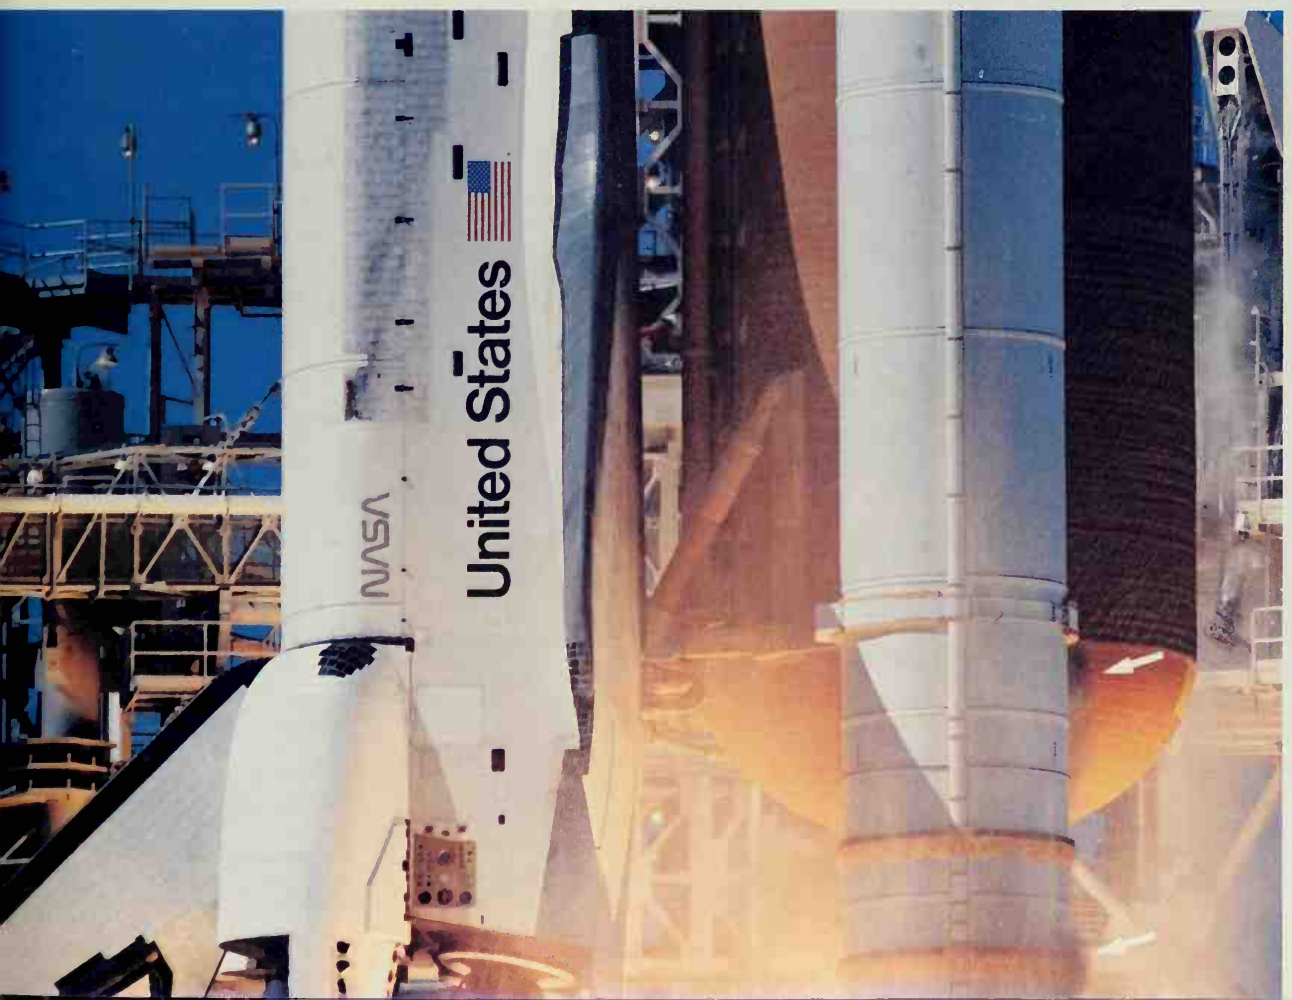
Immediately after solid rocket motor ignition, dark smoke (arrows) swirled out between the right hand booster and the External Tank. The smoke's origin, behavior and duration was approximated by visual analysis and computer enhancement of film from five camera locations. Consensus: smoke was first discernible at .678 seconds Mission Elapsed Time in the vicinity of the right booster's aft field joint.

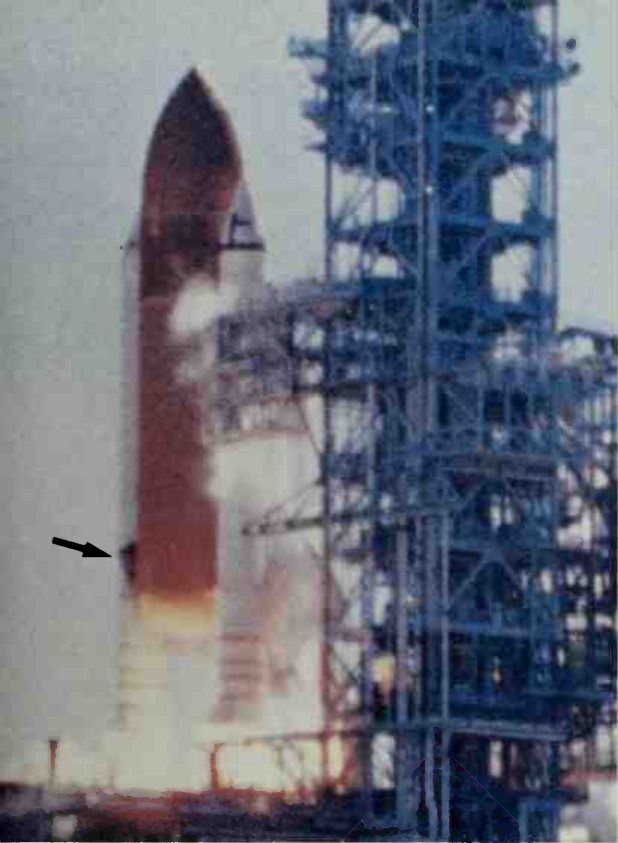
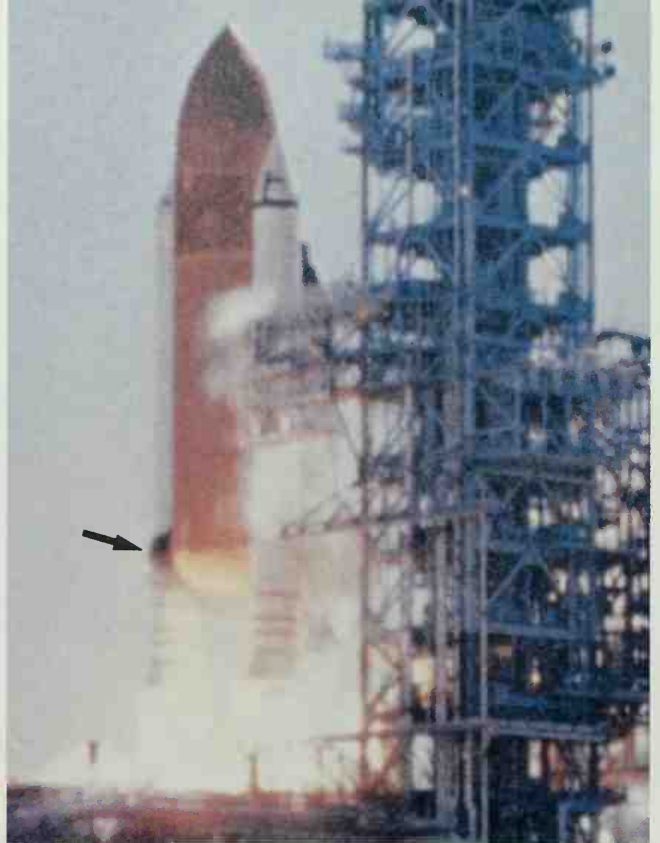
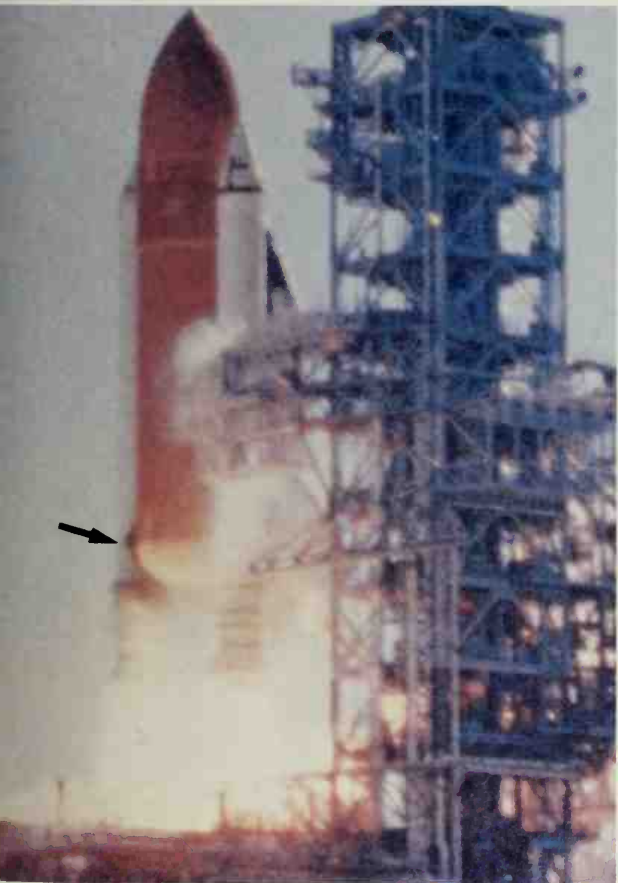
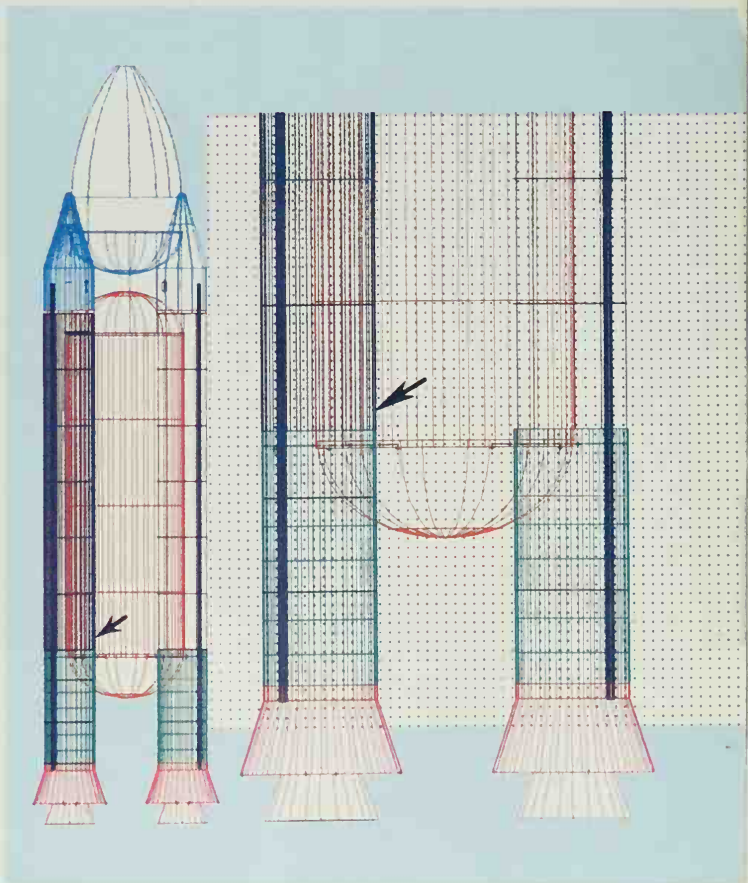
The black color and dense composition of the smoke puffs suggest that the grease, joint insulation and rubber O-rings in the joint seal were being burned and eroded by the hot propellant gases.

Multiple smoke puffs are visible in the photo above (arrows). They began at .836 seconds and continued through 2.500 seconds, occurring about 4 times a second. Upward motion of the vehicle caused the smoke to drift downward and blur into a single cloud. Smoke source is shown in the computer generated drawing (far right).

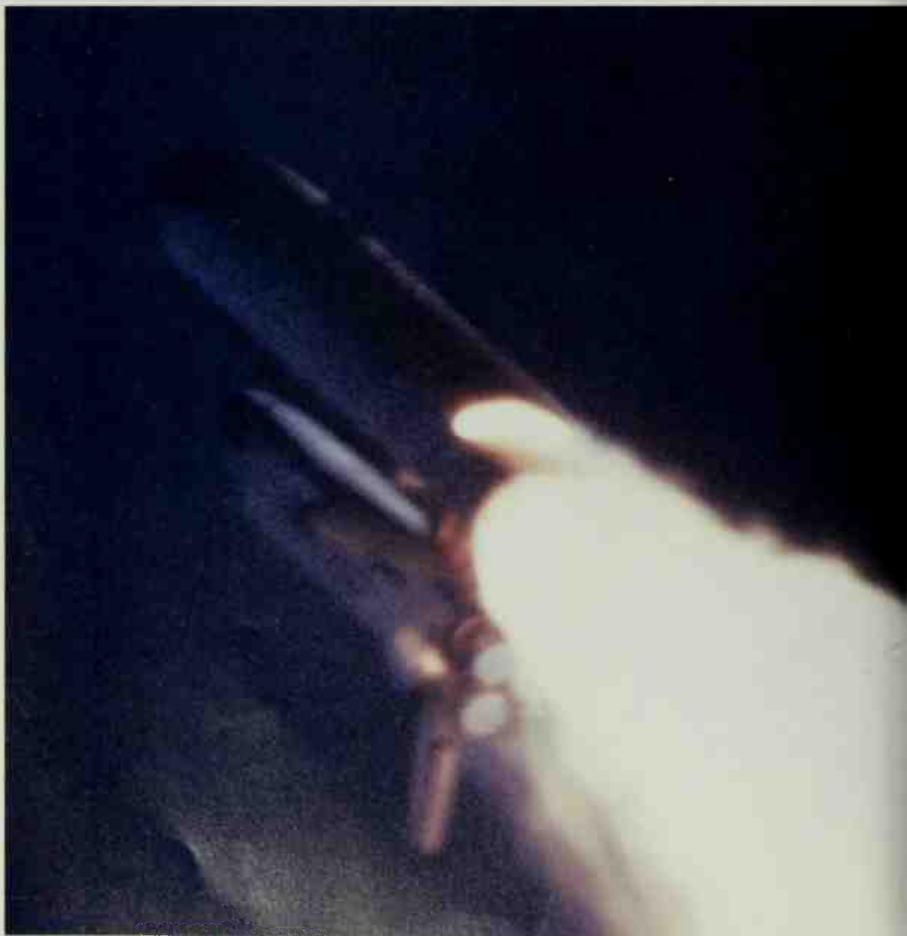
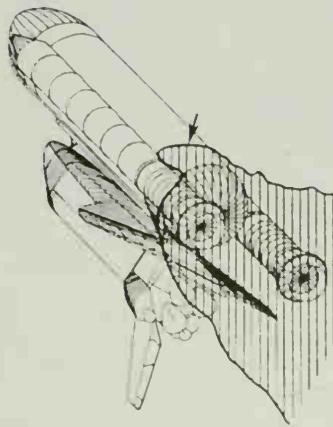
At 58.788 seconds, the first flicker of flame appeared. Barely visible above, it grew into a large plume and began to impinge on the External Tank at about 60 seconds. Flame is pinpointed in the computer drawing between the right booster and the tank, as in the case of earlier smoke puffs. At far right (arrow), vapor is seen escaping from the apparently breached External Tank.

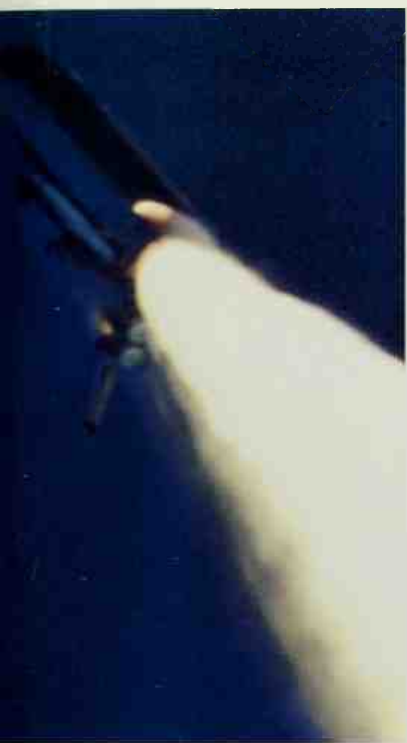
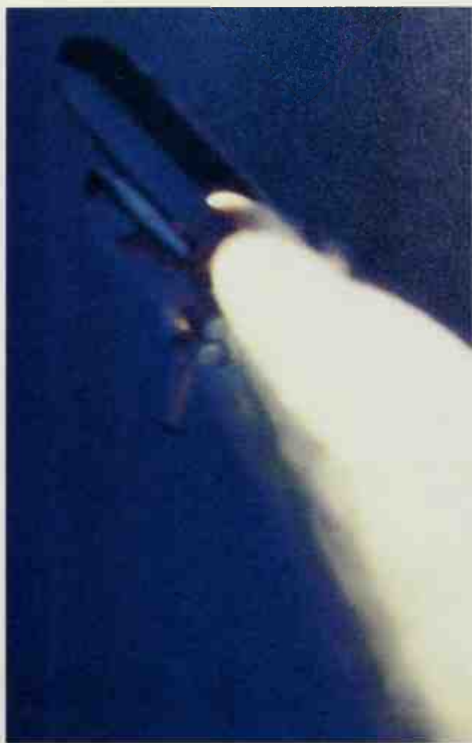
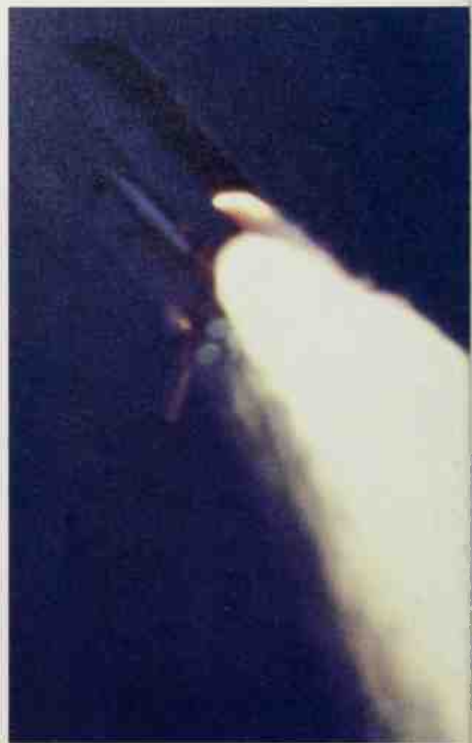
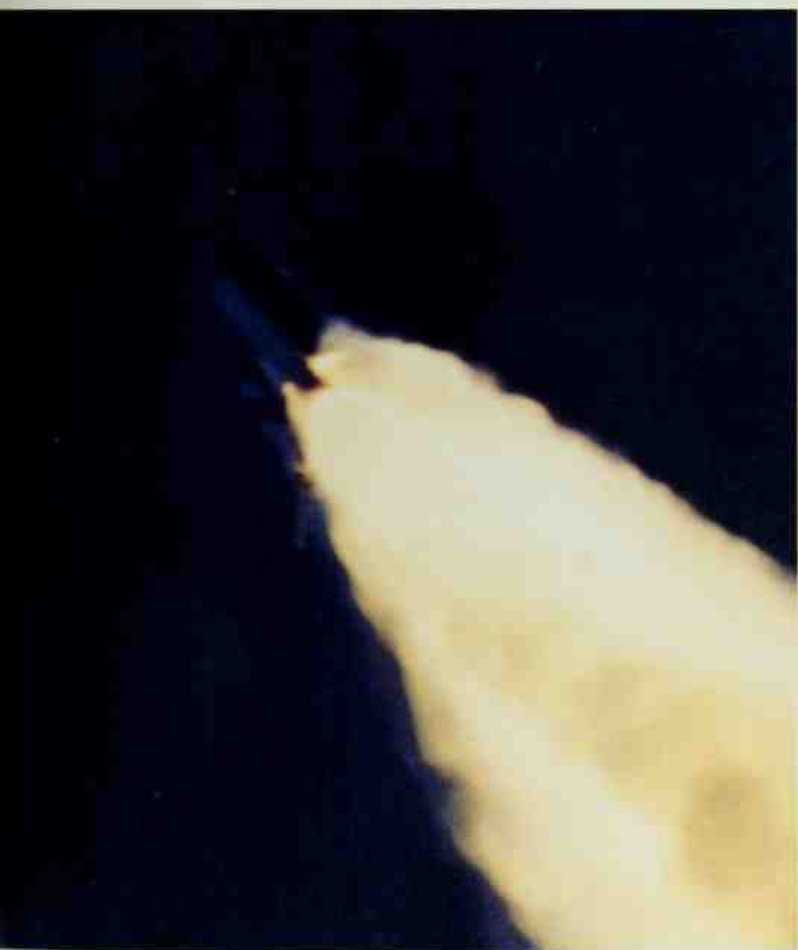
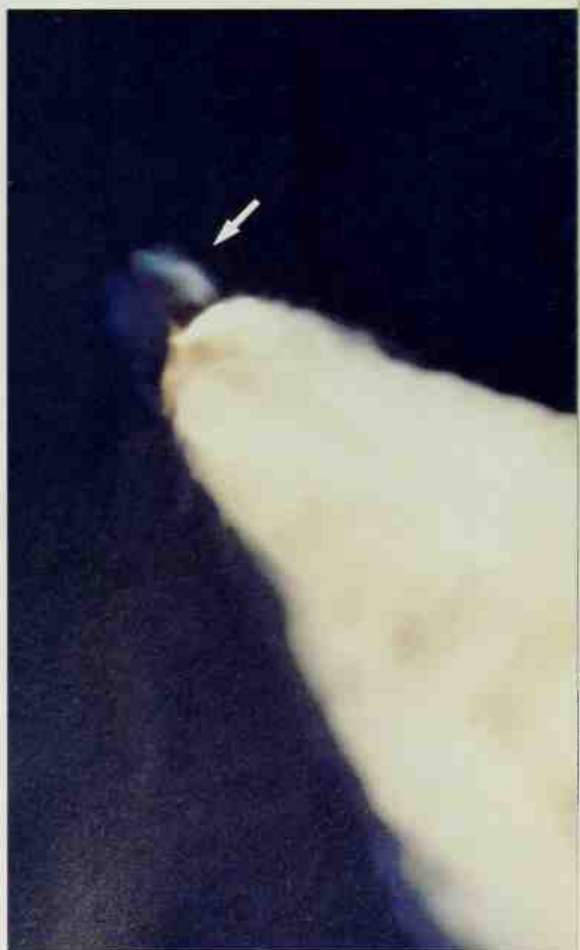
Camera views indicate the beginning of rupture of the liquid hydrogen and liquid oxygen tanks within the External Tank. A small flash (arrows above) intensified rapidly, then diminished. A second flash,

attributed to rupture of the liquid oxygen tank, occurred above the booster/tank forward attachment (below left) and grew in milliseconds to the maximum size indicated in the computer drawing.

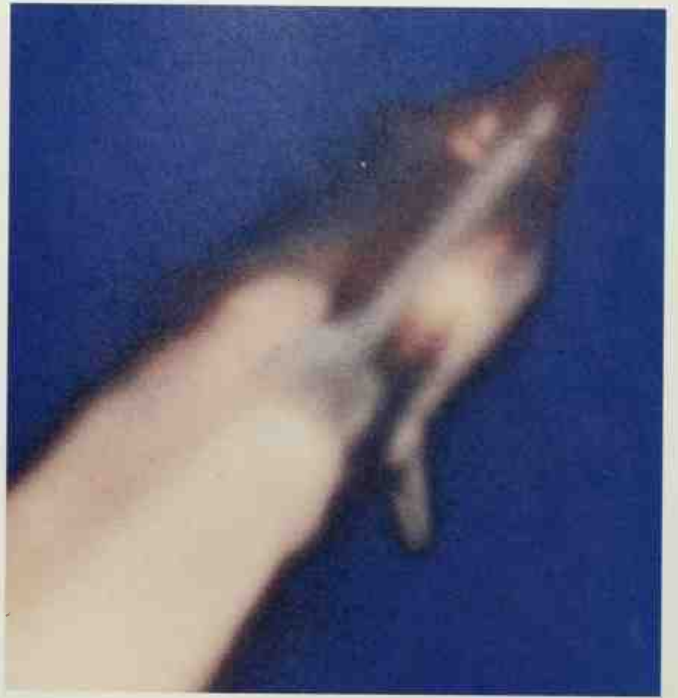
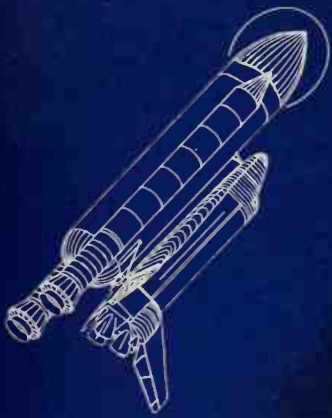
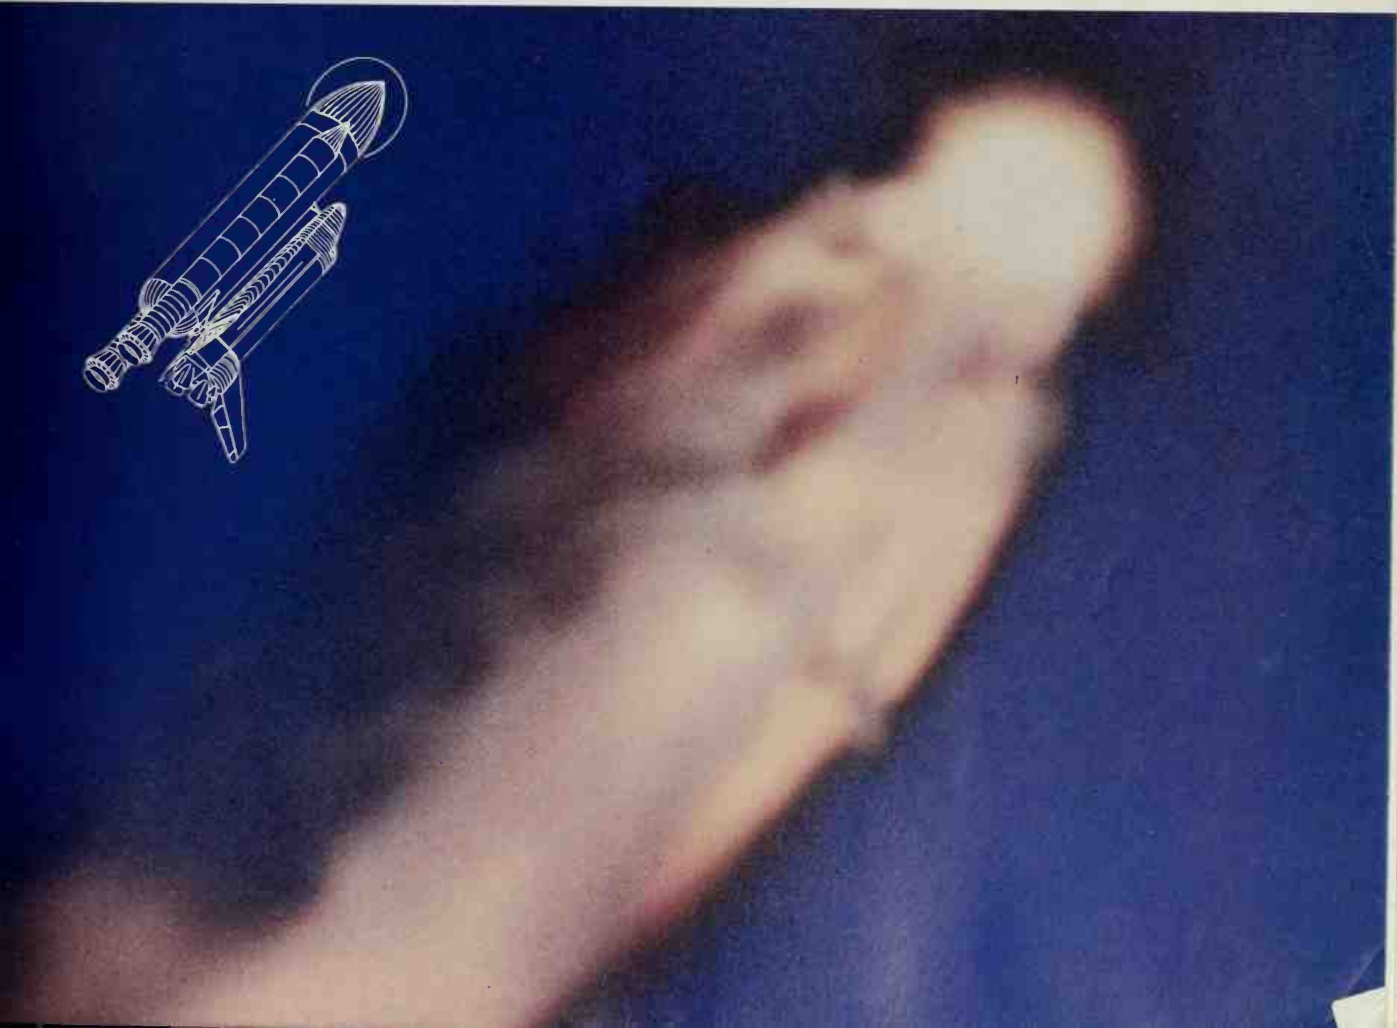
Structural breakup of the vehicle began at approximately 73 seconds. Fire spread very rapidly. Above, a bright flash (arrow) is evident near the nose of the Orbiter, suggesting spillage and ignition of the spacecraft's reaction control system propellants. At left, the two Solid Rocket Boosters thrust away from the fire, crisscrossing to form a "V." The right booster—identifiable by its failure plume—now to the left of its counterpart. At right, the boosters diverge farther; the External Tank wreckage is obscured by smoke and vapor. The Orbiter engines still firing, is visible at bottom center.

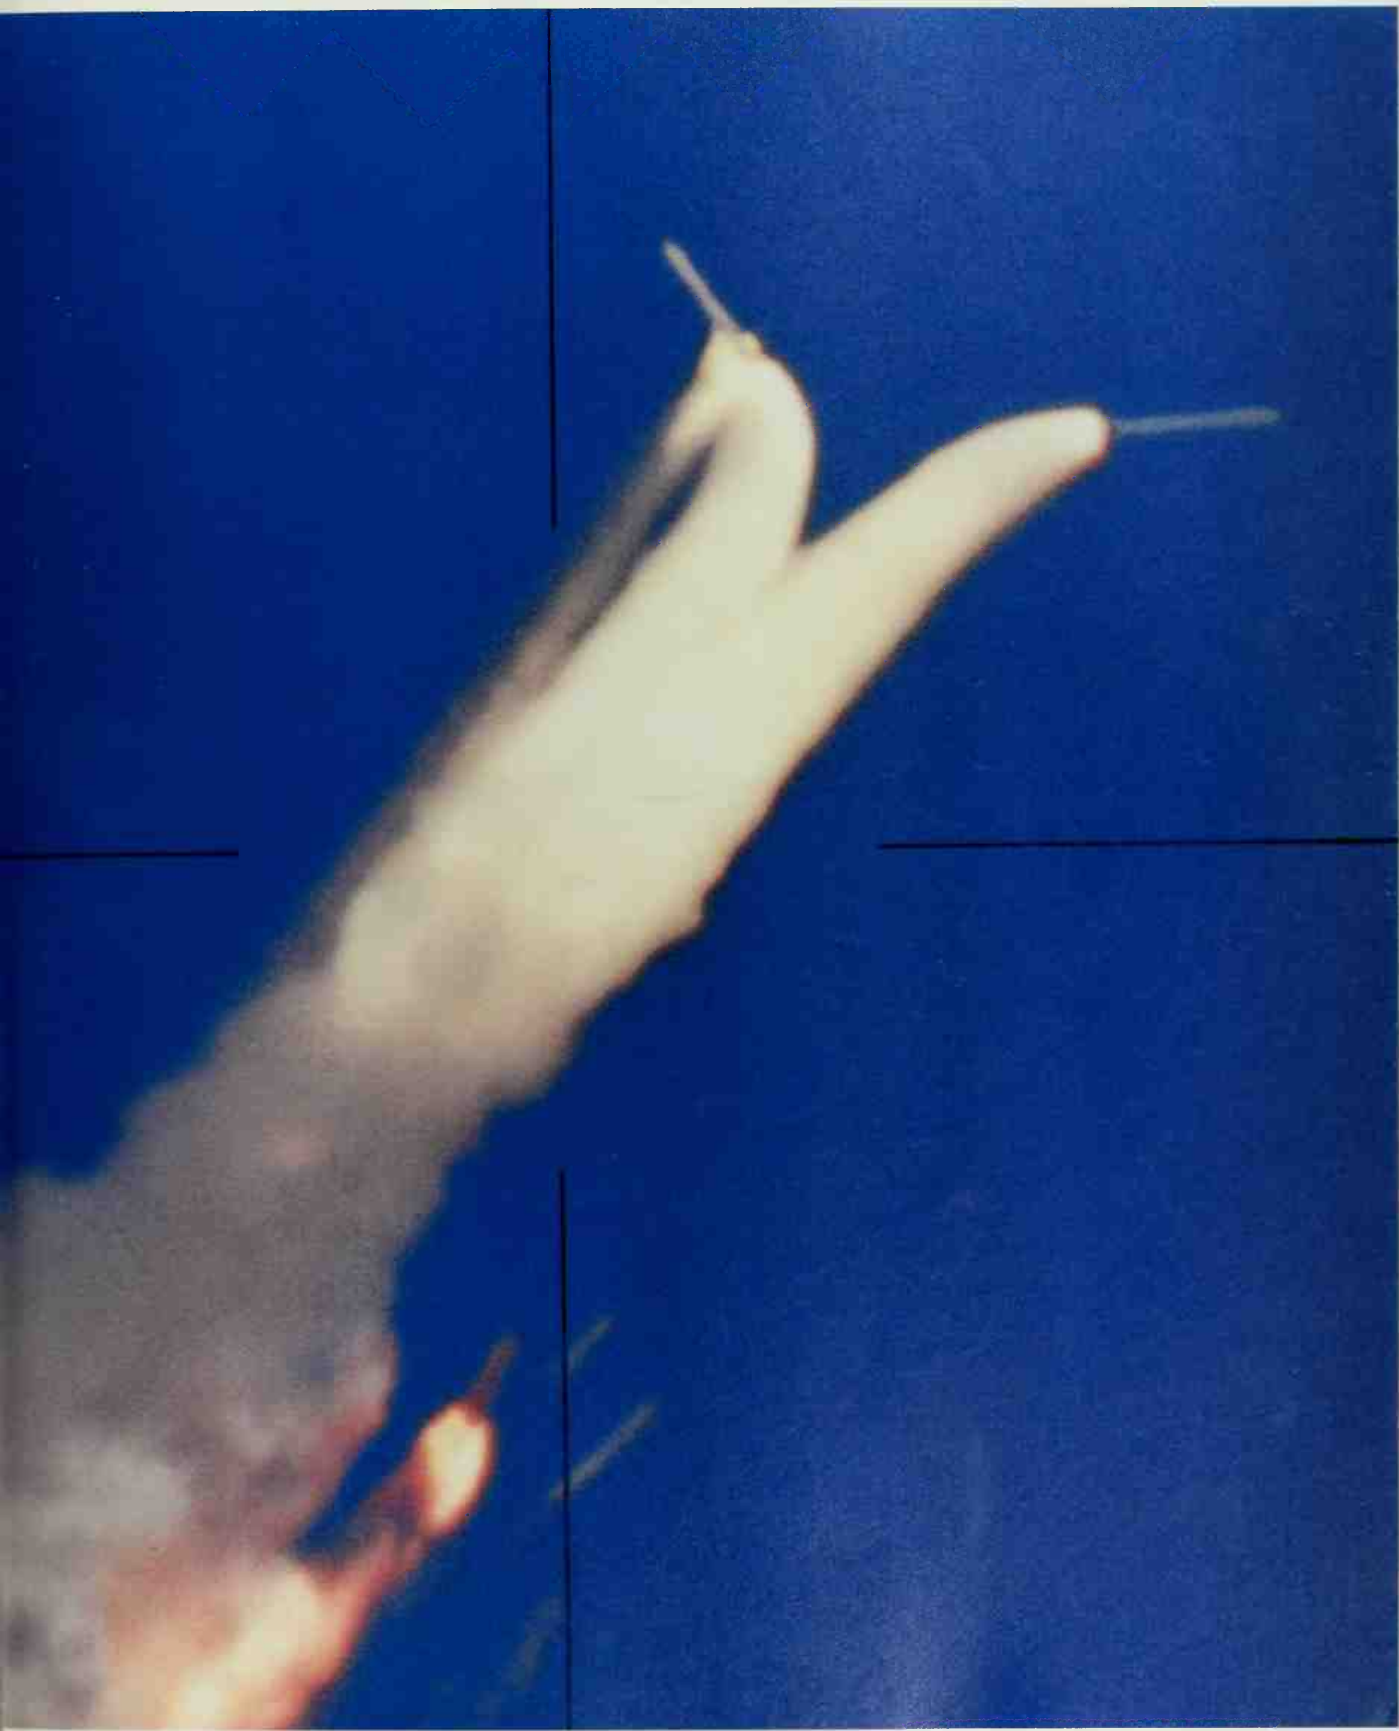
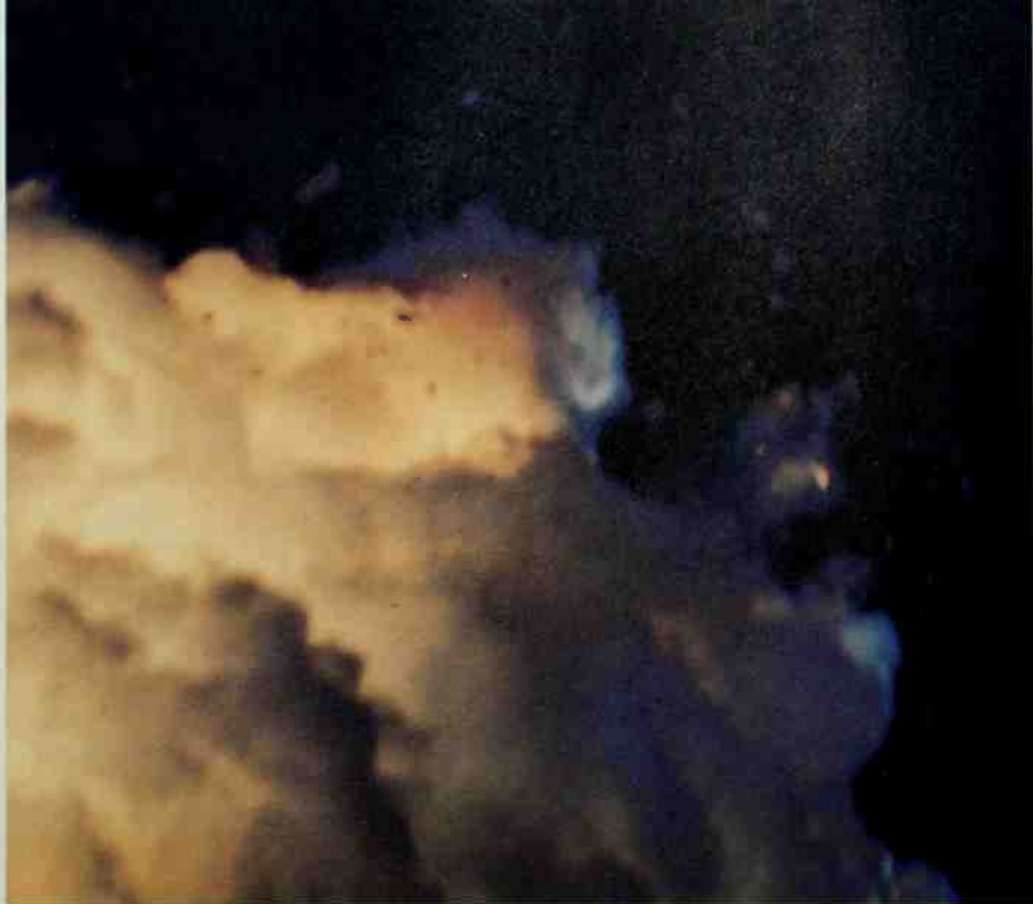
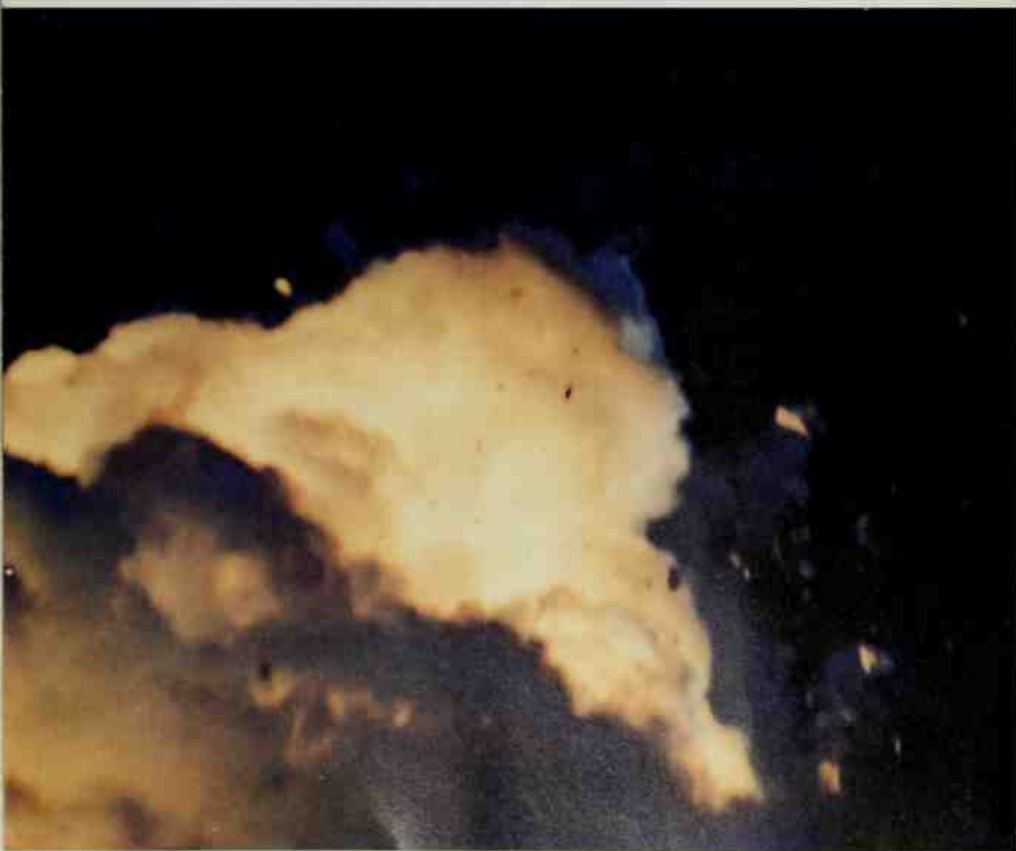
At about 76 seconds, unidentifiable fragments of the Shuttle vehicle can be seen tumbling against a background of fire, smoke and vaporized propellants from the External Tank (left). In the photo at right, the left booster (far right)

soars away, still thrusting. The reddish-brown cloud envelops the disintegrating Orbiter. The color is characteristic of the nitrogen tetroxide oxidizer in the Orbiter Reaction Control System propellant.

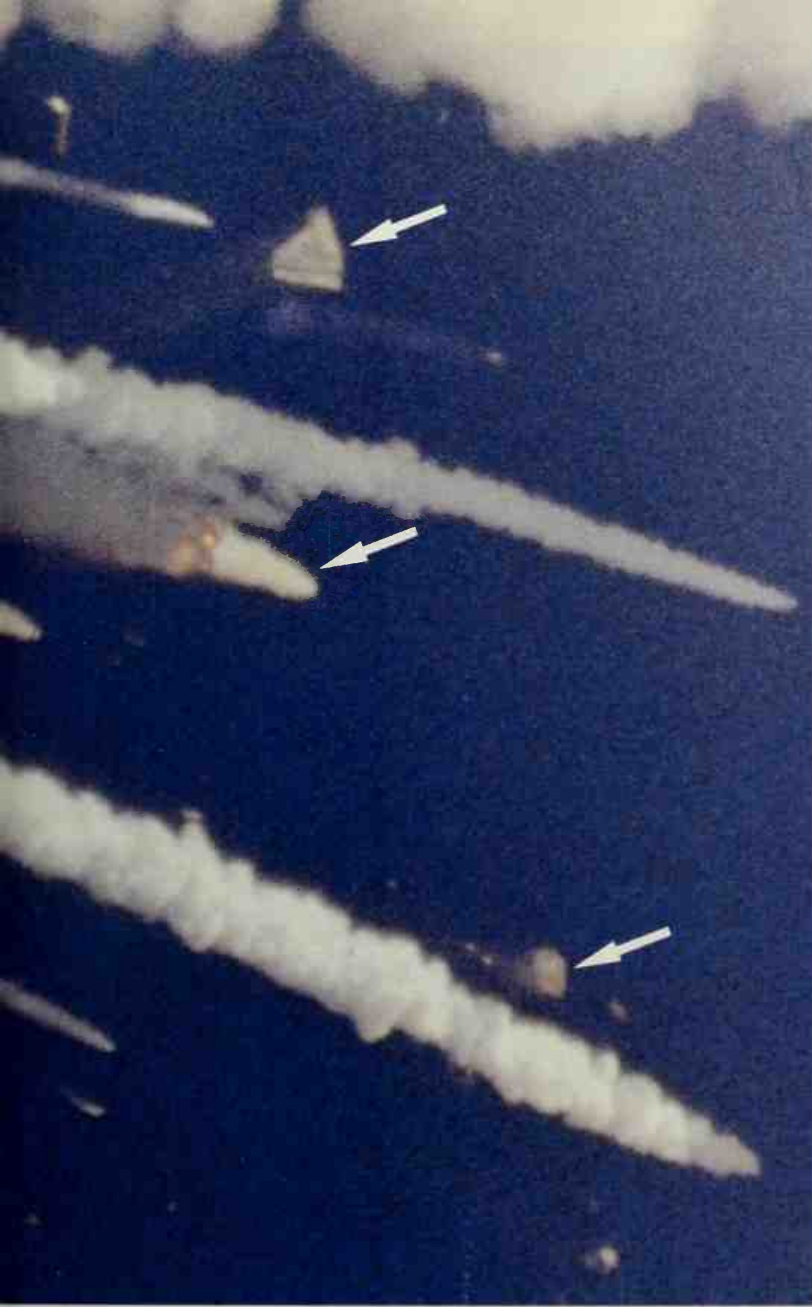
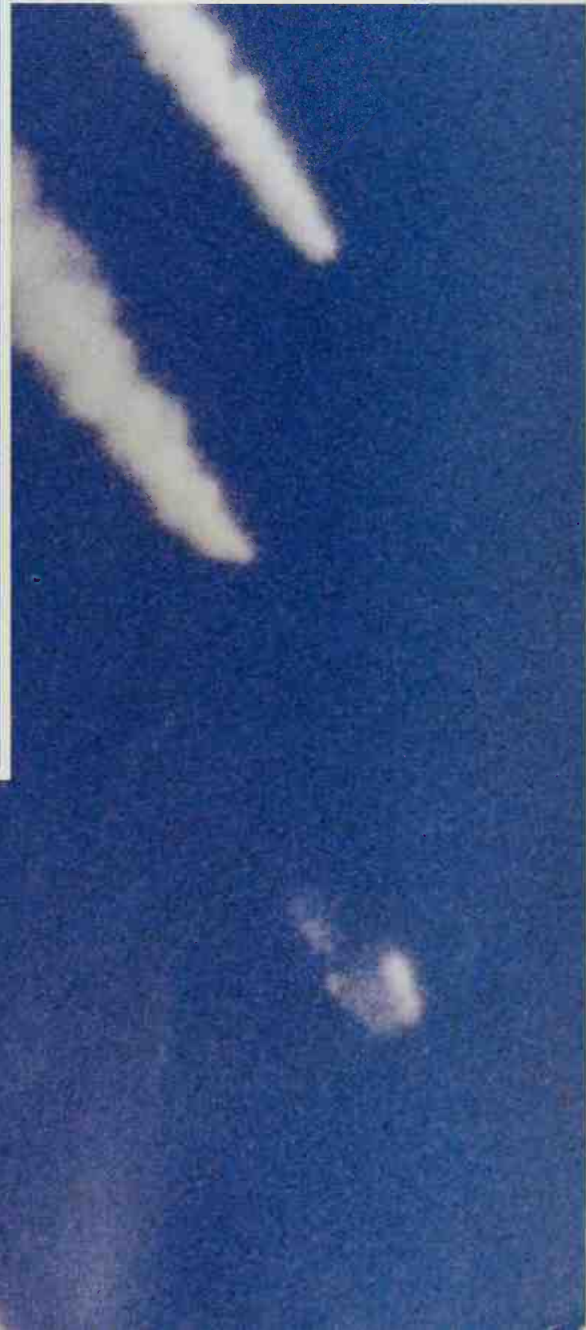
Hurling out of the fireball at 78 seconds (left) are the Orbiter's left wing (top arrow), the main engines (center arrow) and the forward fuselage (bottom arrow). In the photo below, it plunges Earthward, trailed by smoking fragments of Challenger.

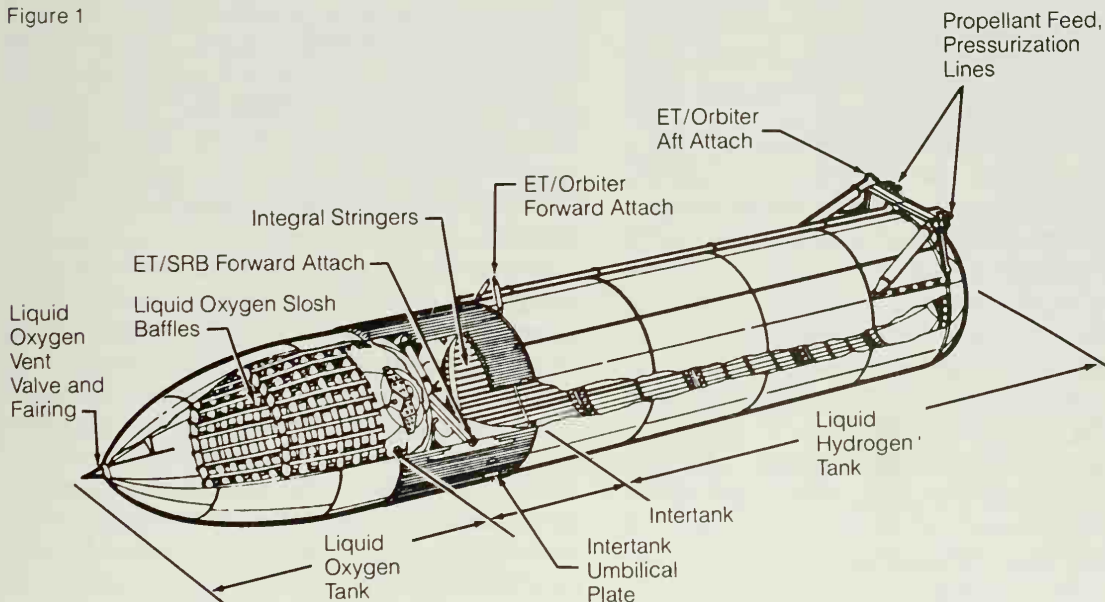
Figure 1

The possibility of an imperfection existing in either the pressurized or nonpressurized External Tank structural elements that could grow to a sufficient size to cause structural failure was examined in detail. All construction history, structural qualification test data, proof test inspection records and x-rays were reviewed. One previously

undetected imperfection that was discovered during a reexamination of the x-rays was found in recovered hardware with no propagation indicated.<sup>3</sup> Other data from the pre-launch ice and frost team inspections, film and video coverage, pressurization records and flight data revealed no evidence of leakage. The Commission concluded that no structural imperfections existed that could have grown to a size to create a leak or cause catastrophic failure of the External Tank.

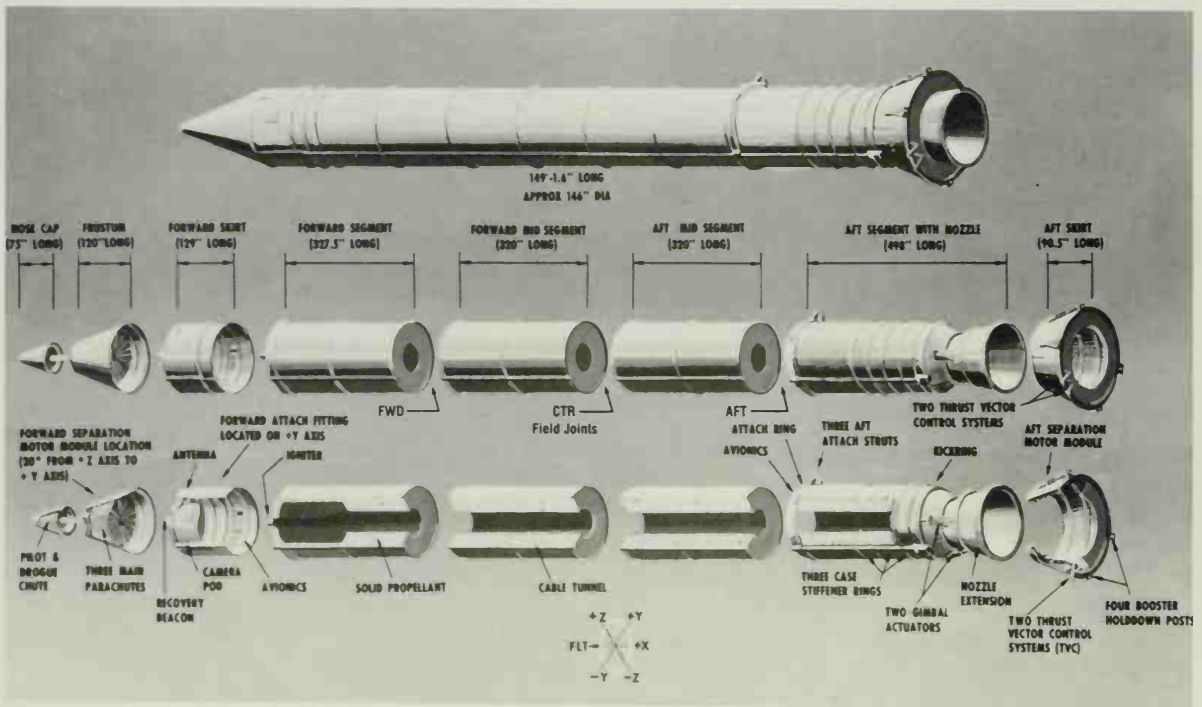
Reconstructed lift off and flight loads were compared with design loads to determine if a structural failure may have caused the accident. The STS 51-L loads were within the bounds of design and capability and were not a factor. Photographic and video imagery confirmed that both Solid Rocket Boosters remained structurally intact until the time of the explosion except for the leak observed on right Solid Rocket Motor.

During stacking operations at the launch site, four segments are assembled to form the Solid Rocket Motor. The resulting joints are referred to as field joints, located as depicted in Figures 8 and 13. Joint sealing is provided by two rubber O-rings with diameters of 0.280 inches (+0.005, -0.003), which are installed, as received from Morton Thiokol, during motor assembly. O-ring static compression during and after assembly is dictated by the width of the gap

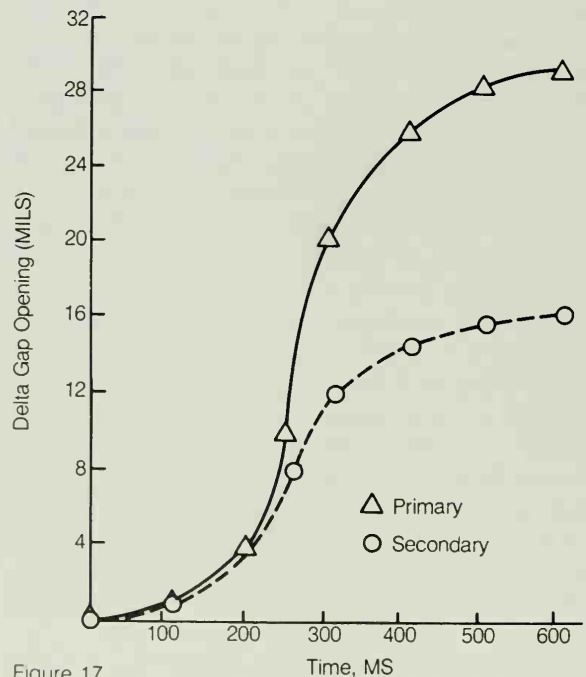
The joint deflection analysis established time histories for gap openings for primary and secondary O-rings for all field joints. For the aft field joints these data indicate gap opening increases of approximately 0.029 inches and 0.017 inches for the primary and secondary O-rings respectively. These values were used for sub-scale dynamic tests. Due to differences in motor pressure and loads, the gap opening increases for forward field joints are approximately 0.008 inches greater than for the aft field joints. Gap opening changes (called delta gap openings) versus time are shown in Figure 17 for the aft field joints. The total gap at any time also depends on the initial static gap, on rounding effects during segment pressurization, and on loadings due to struts and airloads. Sub-scale tests were run containing combinations of the above variables, but did not include the effects of the struts and airloads.

Figure 17 Graph plots changes in right booster's aft field joint primary and secondary gap openings. Horizontal scale is time in milliseconds from ignition.

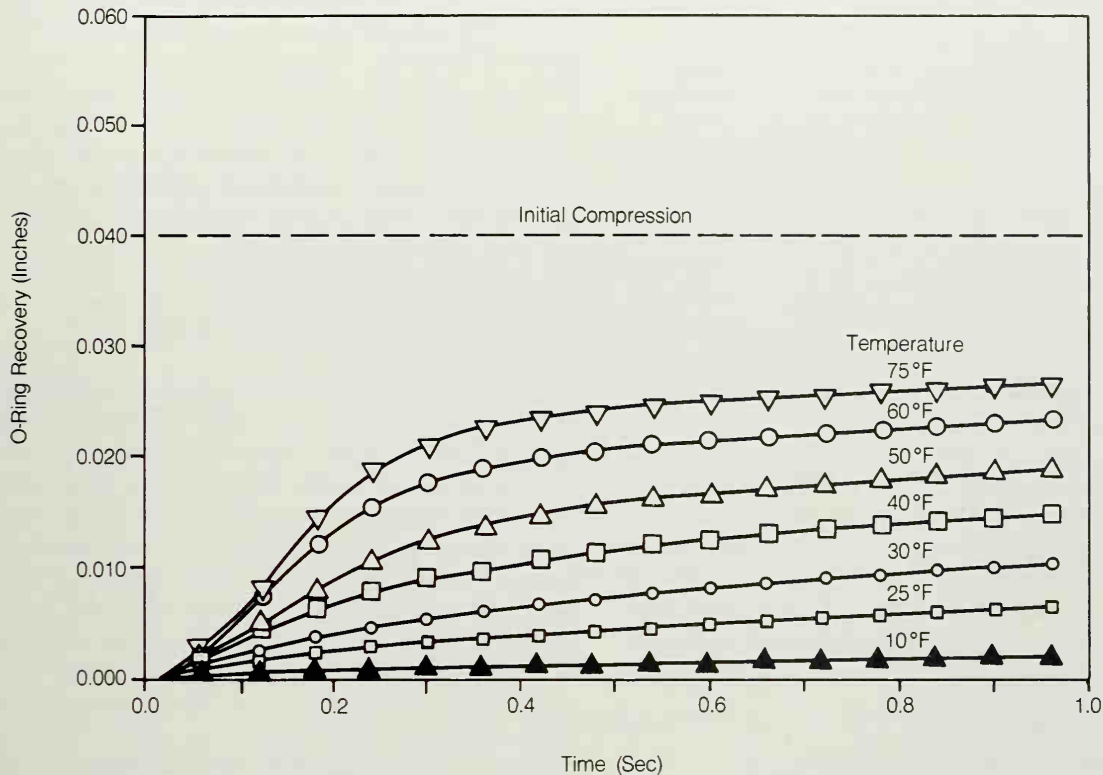
Consistent results from numerous O-ring tests have shown a resiliency degradation with reduced temperatures. Figure 23 provides O-ring recovery from 0.040 inches of initial compression versus time. This shows how quickly an O-ring will move back towards its uncompressed shape at temperatures ranging from 10 to 75 degrees Fahrenheit. When these data are compared with the gap openings versus time from Figure 17, it can be seen that the O-rings will not track or

Figure 23  
Graph plots O-ring shape recovery in inches against time in seconds for a variety of temperatures.

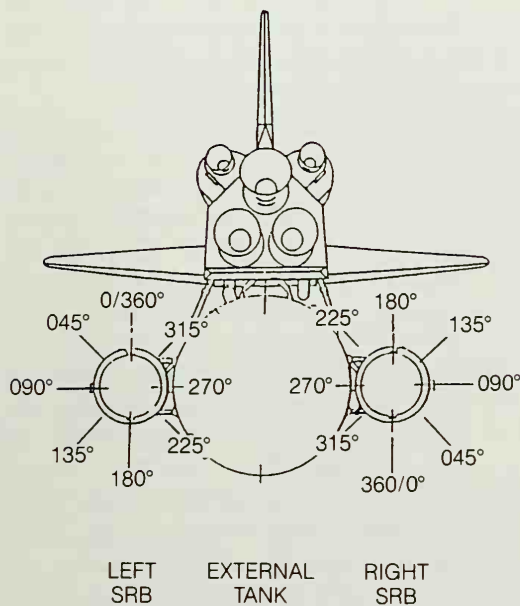
Figure 26

parts 131, the upper segment tang region, and part 712, the lower clevis region of the joint. This burned area extends roughly from station 1476, in the upper section, to 1517 on the lower region. In a circumferential direction (see figure 26) the lower end of the eroded region extends from roughly 291 degrees to 320 degrees and the upper eroded section extends between 296 and 318 degrees. Note that the region at about 314 degrees includes the attachment region of the strut to the attachment ring on the right Solid Rocket Booster.

307-degree circumferential position. Although irregular, the hole is roughly rectangular in shape, extending approximately 27 inches circumferentially along the tang (296 to 318 degrees) with total burnout extension approximately 15 inches forward of the tang. At either side in the interior of the hole (photo K) the insulation and steel case material showed evidence of hot gas erosion that beveled these surfaces (indicative of combustion products flowing through the hole from the interior of the Solid Rocket Motor). The top surface of the hole was hardly beveled at all. The

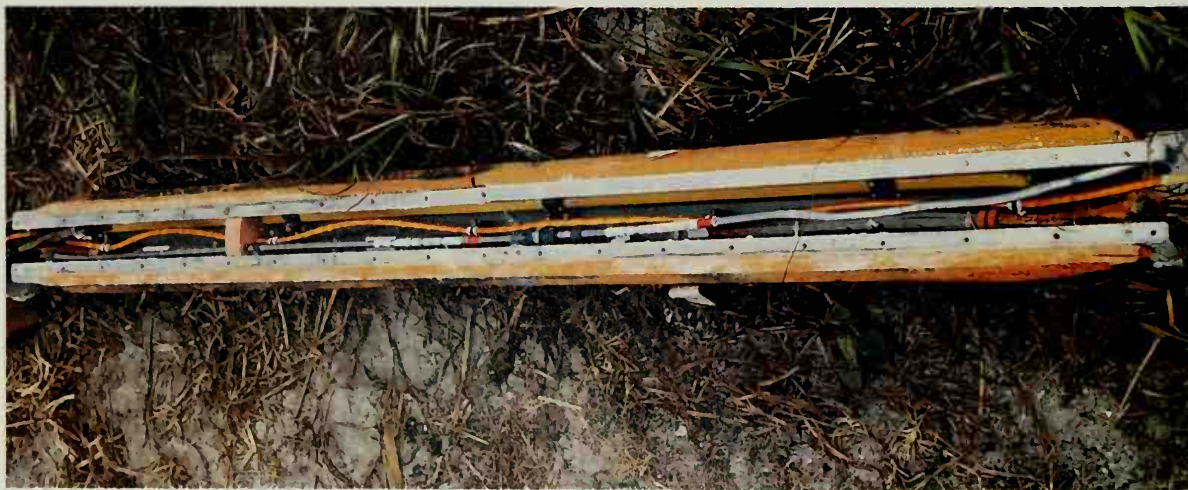
A The upper photos show, from left to right, the left side of the Orbiter (unburned), the right lower and upper rudder speed brake (both burn damaged) and left upper speed brake (unburned), confirmation that the fire was on the

right side of the Shuttle stack. The lower photos show the range safety destruct charges in the External Tank. These charges were exonerated when they were recovered intact and undetonated.
